# **Closure Report**

Interim Repair Action OU A Charleston Beach

# **Bremerton Naval Complex**

Bremerton, Washington

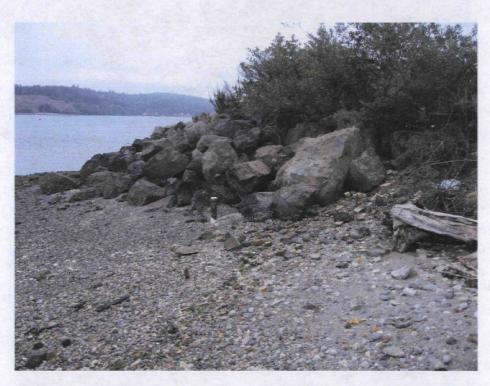
Looking west at erosion gauge along riprap wall, 30 July 2007.

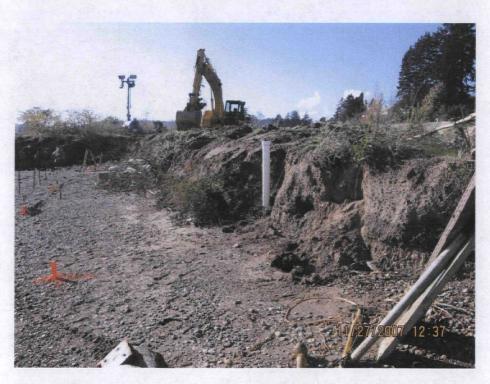
Erosion around embankment gauge, 27 November 2007.

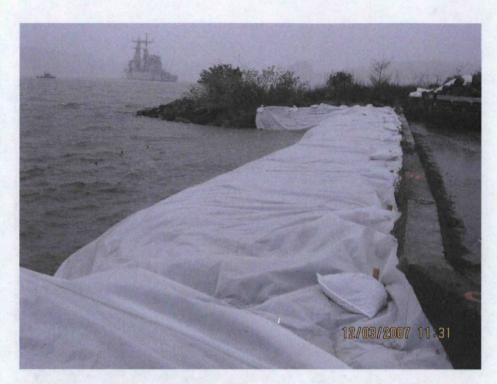
Heavy rains and high tide, 3 December 2007.

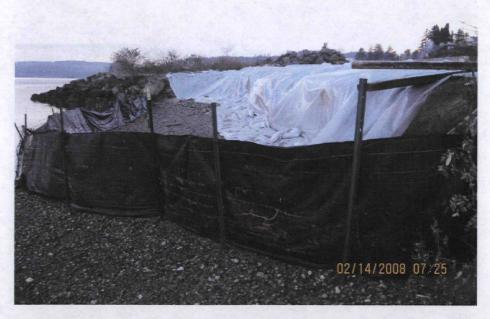
Silt fence prior to relocation, 14 February 2008.

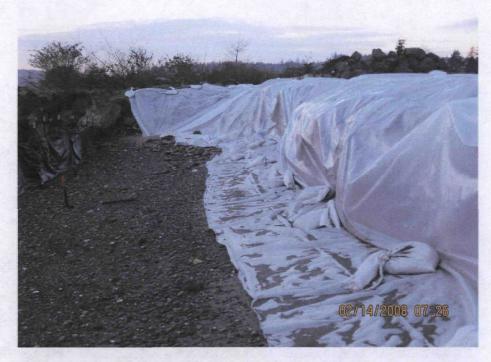
Shoreline slough contained by plastic sheeting, 14 February 2008.

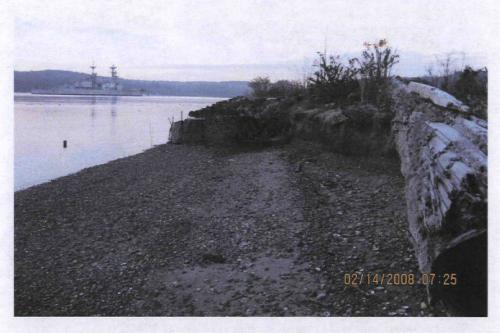
Looking west at silt fence and eroding bluff from east side, 14 February 2008.

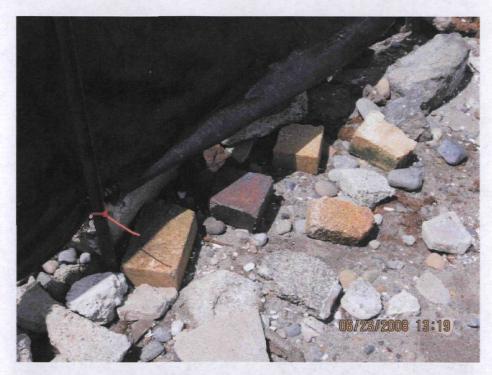
Close-up of debris in southwest corner, 14 February 2008.

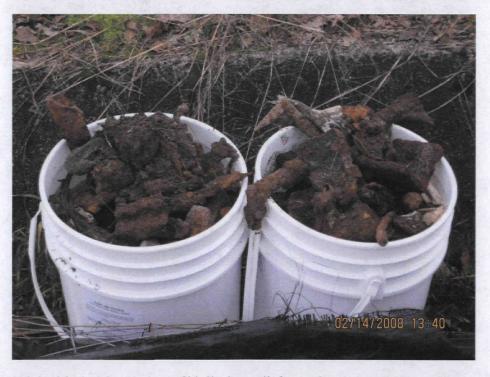
Debris picked up from in front of bluff prior to silt fence relocation, 14 February 2008.

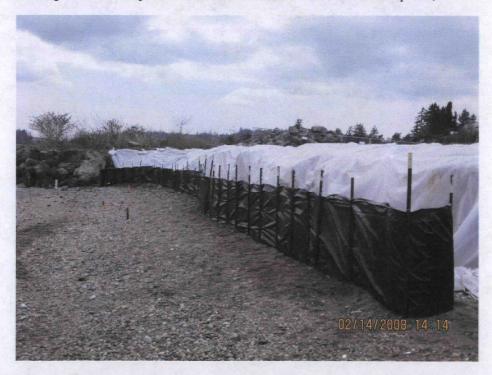
Silt fence after relocation to minimize fish entrapment, 14 February 2008.

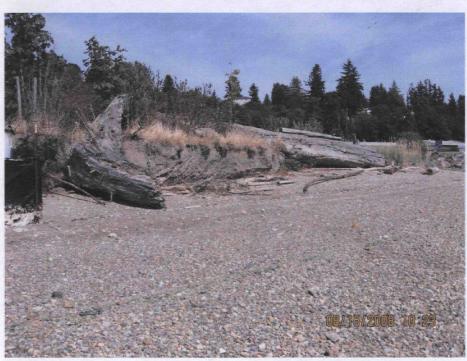
Looking at woody debris and bluff just east of project site, 15 August 2008.

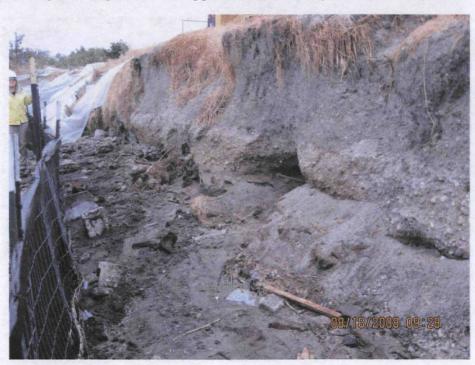
Eroded bluff with debris present on beach, 18 August 2008.

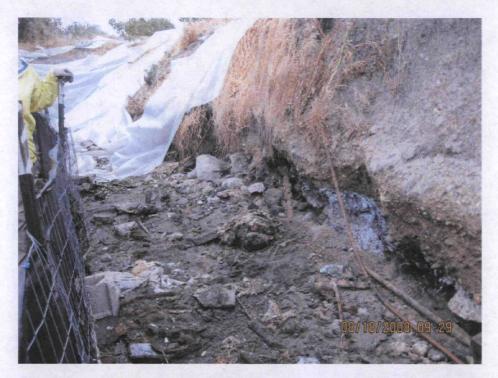
Close-up of eroded bluff and fill material in southwestern corner of site, 18 August 2008.

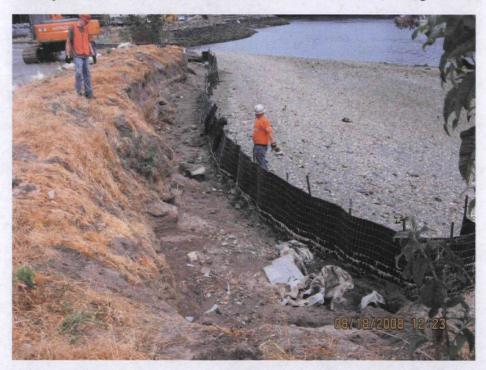
Looking east along eroded bluff, 18 August 2008.

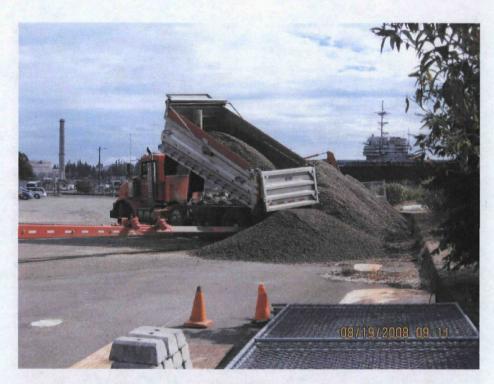
Offloading of fish mix material, 19 August 2008.
